# FACILITY COMPLIANCE INSPECTION REPORT

## Division of Waste Management Solid Waste Section

**Date of Site Inspection:** June 6, 2014

Apple's LCID Landfill  
 Elon-Ossipee Road  
 Elon, NC 27244

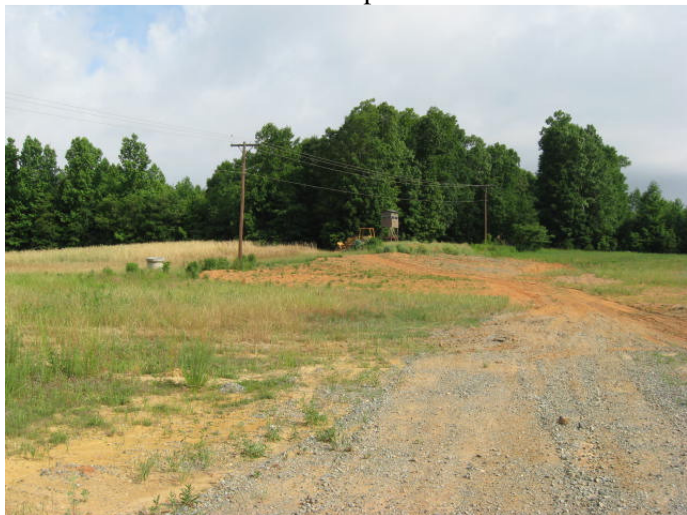
LCID landfill – view across top

6. Maintain at least one foot of suitable soil cover atop the landfill.
7. Ensure that water does not pool atop the landfill area.
8. Sow grass seed atop bare areas of the landfill cap.

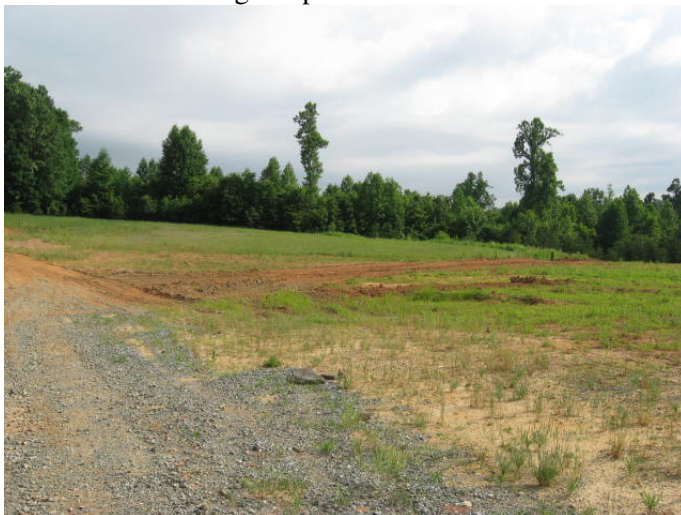
LCID landfill – right top

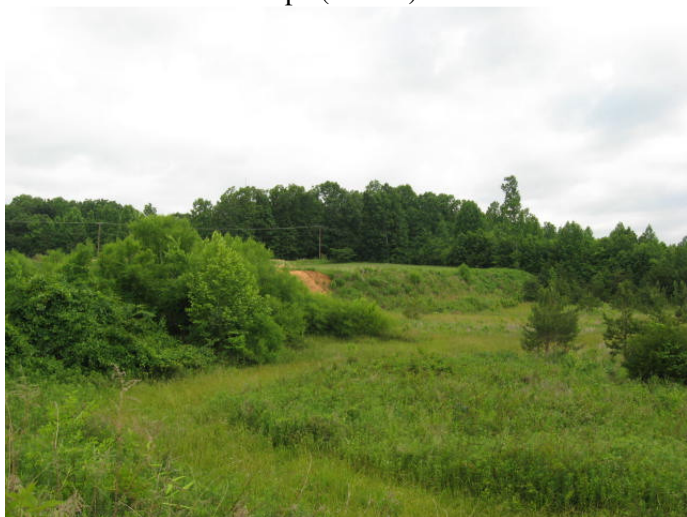
LCID landfill – side slope (view 1)

5. Side slopes should be graded and covered with soil such that a 3:1 slope ratio is obtained or a ratio of which no indication of erosion or runoff is observed.

9. Repair erosion rills.
10. The facility is secured by a locked gate.
11. Access roads are of all-weather construction.

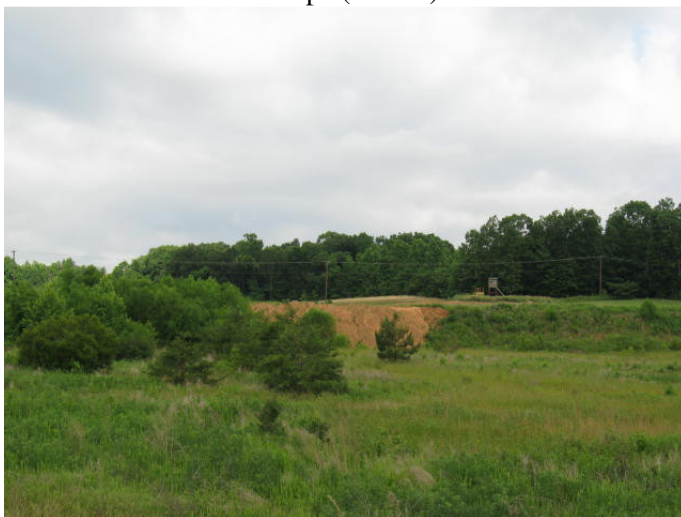
LCID landfill – side slope (view 2)
